## Print Quality Defect – Light or Faded Print – Lexmark MS/MX71x/81x

Document ID:TE548

Technical Service Bulletin		Problem Description
<b>Machine Type/Model</b>	4063 - xxx 7463 - xxx	<p>The printout across all areas of the page is faded or lighter than expected or desired.</p> <p style="text-align: center;"><b>Solution</b></p> <p>See diagnostic procedure below.</p>
<b>Date Created</b>	06/13/2013	
<b>Last Updated</b>	10/18/2016	
<b>Safety Issue?</b>	No	
<b>Code Update?</b>	No	
<b>Engineering Change?</b>	No	
<b>New Parts?</b>	No	
<b>Old Parts Status</b>	n/a	
<b>Voltage: 120/240</b>	All	
<b>Serial No. Range</b>	All

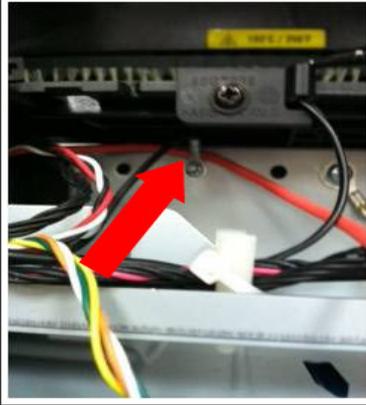
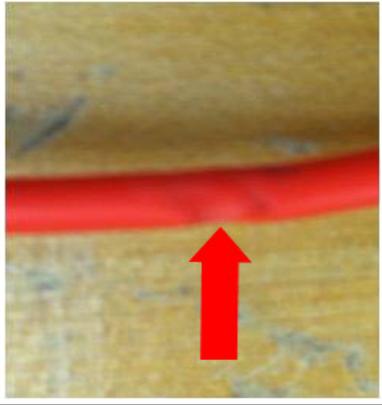
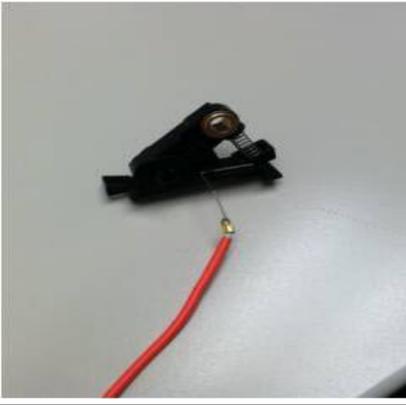
Step	Action
<b>1</b>	Turn the printer off and back on to see if recalibration corrects the darkness variation.
<b>2</b>	<p>Check the <b>wire that connects the HVPS to the transfer roll</b>. If the <b>wire is pinched</b> or damaged (as shown in the images below), the transfer roll will not receive enough voltage from the HVPS, which in turn causes the print defect.</p> <p style="text-align: center;"><b>Damaged wire connecting the transfer roller from HVPS. The wire may be pinched during manufacturing.</b></p> <div style="display: flex; justify-content: space-around;">

</div>
<b>3</b>	If wire is damaged, replace <b>40X7605</b> – Transfer roller arm with cable.
<b>4</b>	Escalate the issue to Lexmark 3rd Level Support should issue persist.
