Bulletin: COLOR-115 Date: 11/20/2008

Models: e-STUDIO 6530c Series

Subject: C4E2 Error Code

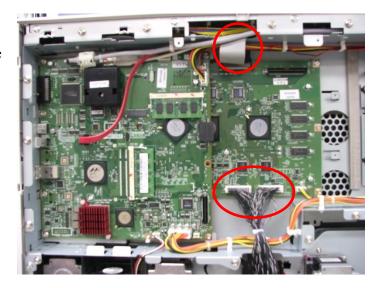
4.3 - Disconnect 3 connectors on the IMG board.

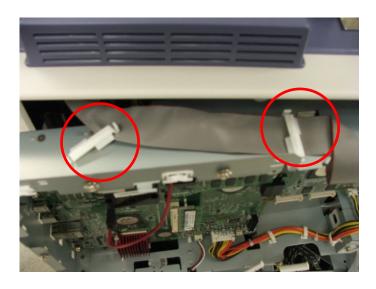
4.8 - Open the SYS board case slightly. Then release the harness from 2 clamps and remove the harness from the SYS board case.

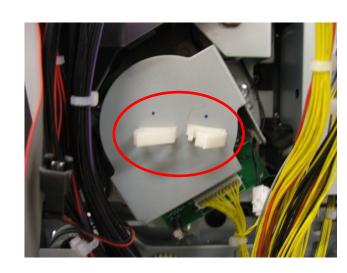
5.5 - Remove 2 cable clamps by pushing in and turning clamp until aligned with keyed hole then pull out.

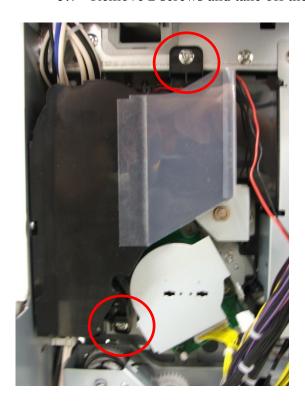
5.7 - Remove 2 screws and take off the duct.

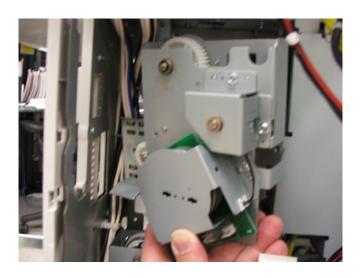
6.4 - Remove 4 screws and carefully remove the fuser drive unit by lifting up and rotating.

- a. Use caution not to drop the screws when removing screws in this area as a dropped screw could fall onto the power supply.
- b. Remove this assembly gently so as not to damage fuser drive gears.

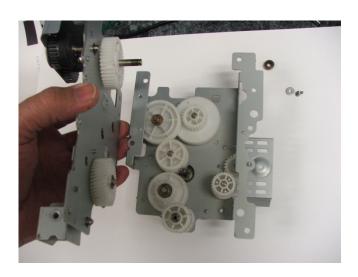
7.3- Carefully remove the top plate and set it aside.

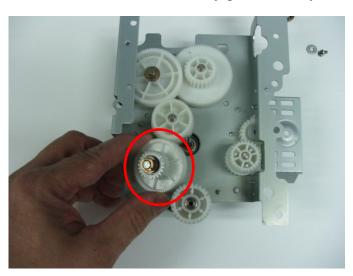
7.4 - Remove the one way gear assembly from the drive unit.

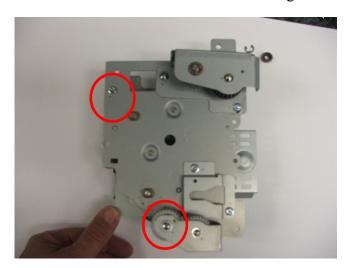
7.12 - Reinstall the 2 screws holding the two halves of the drive unit together.

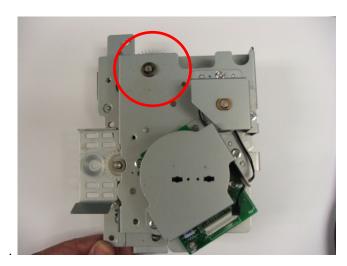
7.13 -Turn the Drive Unit over and reinstall the bushing and E-clip.

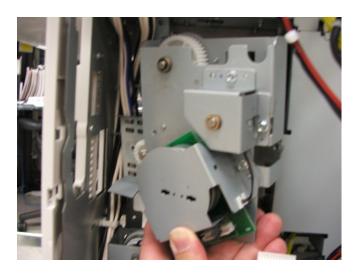
8.1 - Reinstall the drive assembly into the machine. **Note:** Use caution not to pinch the wires when installing the drive unit.

Note: Rear plate of the drive unit should be installed behind wires while outer plate goes in front as shown here.

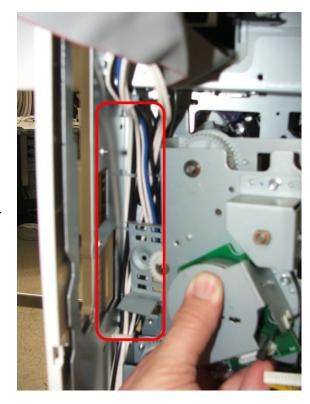
Warning! Do not allow wires to get pinched under the drive unit. This could cause electrical shock and or fire when power is applied.

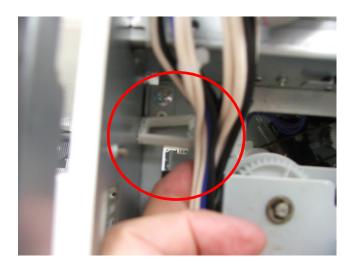
8.3 - Reinstall the frame clip for wire harness and insert the wires into the clip.
